# Soiling Loss Quantification of Roof-Top Mounted Solar Module in Mombasa Using Digital Imagery Techniques

**Key Words:** PV Soiling loss, Solar PV metrology, Irradiance attenuation, Digital image processing, Autocorrelation measurements, Technical University of Mombasa, Kenya

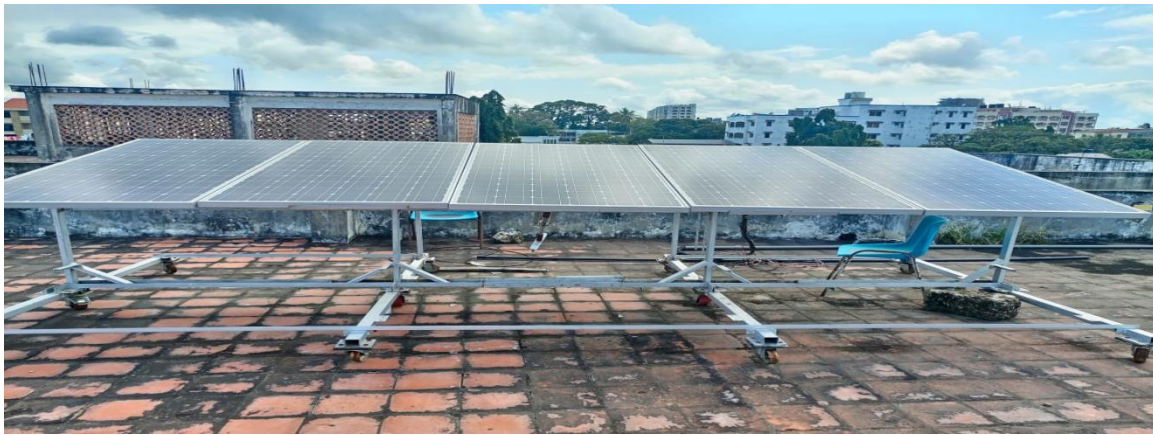
Figure 3. Photos of roof-top solar PV mounted on top of the Renewable Energy Laboratory building at Technical University of Mombasa, Kenya

The study was conducted on a setup that was designed, fabricated and installed on the roof-top of the Renewable Energy Laboratory at Technical University of Mombasa (TUM) (Figure 2). Photographs were captured at exactly 1pm on daily basis for a duration of three months. Two modules' images of both cleaned and soiled photovoltaic panels placed side by side were captured simultaneously. A high-resolution camera of oppo Reno 12 was used. The tripod

was fixed with the distance between the camera and the panel at about 1m. The camera was fixed at around 7 degrees to the panel. Captured images were stored with date-stamped file names for easy tracking.
